IN-PLANE CYCLIC TESTING OF FORMBLOCK[®] MORTARLESS CONCRETE MASONRY WALLS

INTERNATIONAL REPORT

Global Building Systems PTY Ltd
PO Box 182
Nerang
Qld 4211
Australia

August 2006

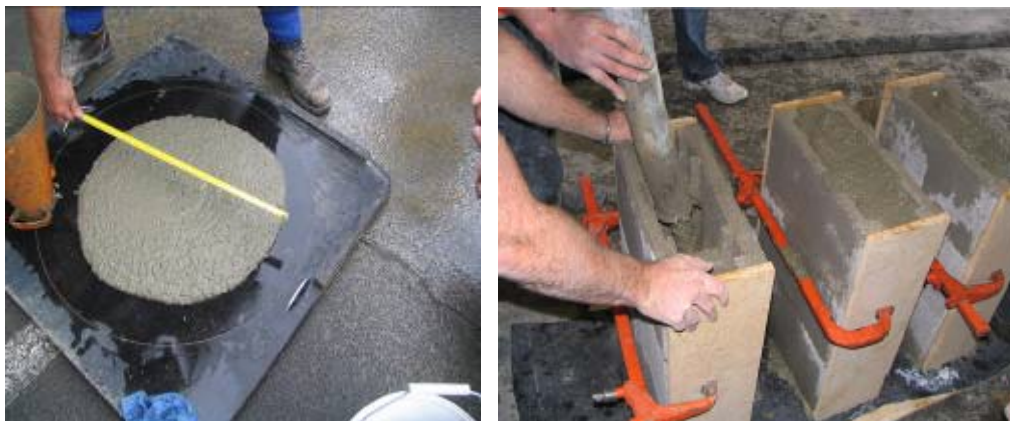
Figure 3-1 Spread test of Formfill and construction of prisms for testing

A total of six masonry prisms were constructed in two sets of three, referred to as Set 1 and Set 2, using 200 mm by 398 mm (7.89 in. by 15.67 in.) Formblock[®] CMU's filled with Formfill concrete. No shrinkage compensating admixture was needed and rodding provided sufficient compaction without the need for vibration. The Formfill concrete was pumped through a grout pump, see Figure 3-1.

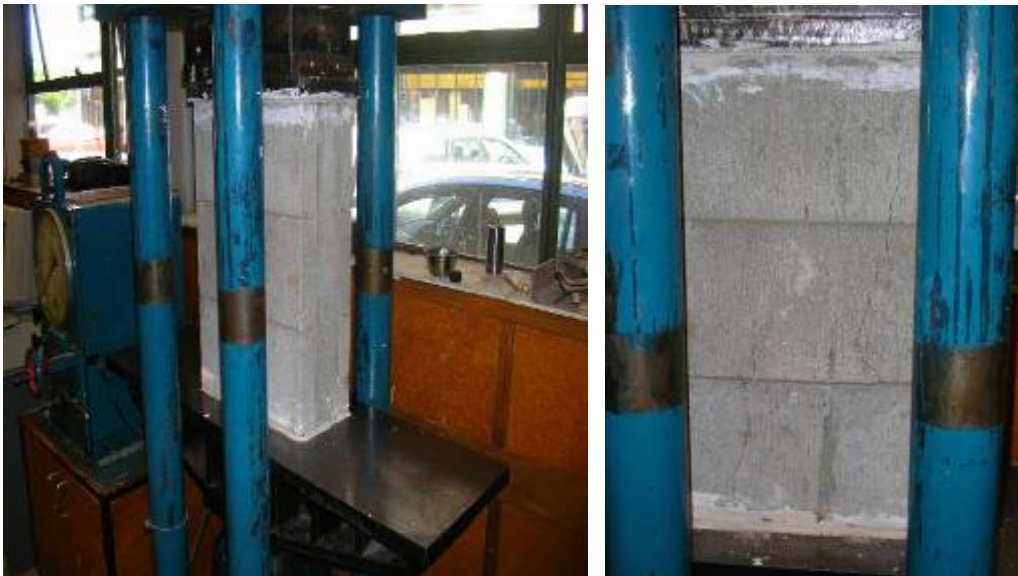
Figure 3-2 Test set-up of masonry prisms

The Set 2 prisms were tested at 28 days using the testing apparatus shown in Figure 3-2. It was observed that the masonry face shells did not delaminate from the inner concrete cores, but that cracking instead occurred across the prisms. This suggested that the superplasticiser was successful in reducing plastic settlement, eliminating the need and cost associated with using a shrinkage compensating admixture. The failure mechanism can be seen in Figure 3-3.

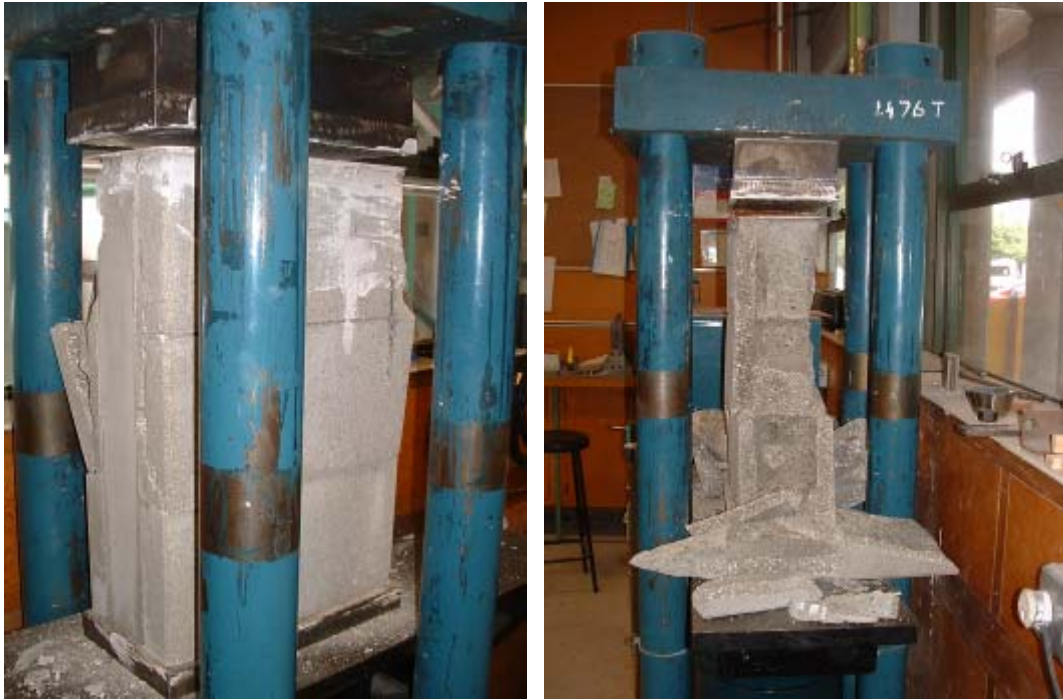
Figure 3-3 Failure mechanism of Set 2 prisms

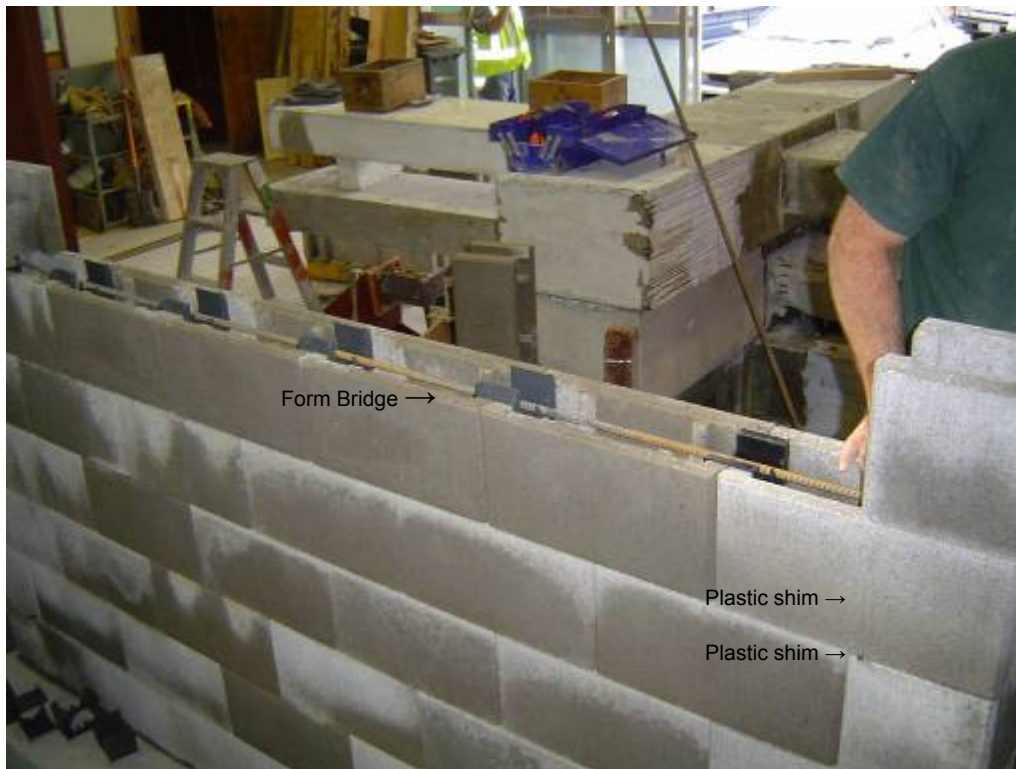
Figure 4-2 Wall construction showing Form Bridges and plastic shims

The lower course of CMU's were laid on a bed of mortar. Plastic bridges, termed Form Bridges, were used in the construction of the wall. Their purpose was to join any two blocks together at their perpendicular ends and to ensure that the reinforcing steel was kept accurately and securely in position. This can be seen in Figures 4-2 and 4-4.

Small plastic shims were installed where required during construction to maintain the vertical alignment of the wall. They can be seen in Figures 4-2 and 4-3. No bonding agent was provided to any joints.

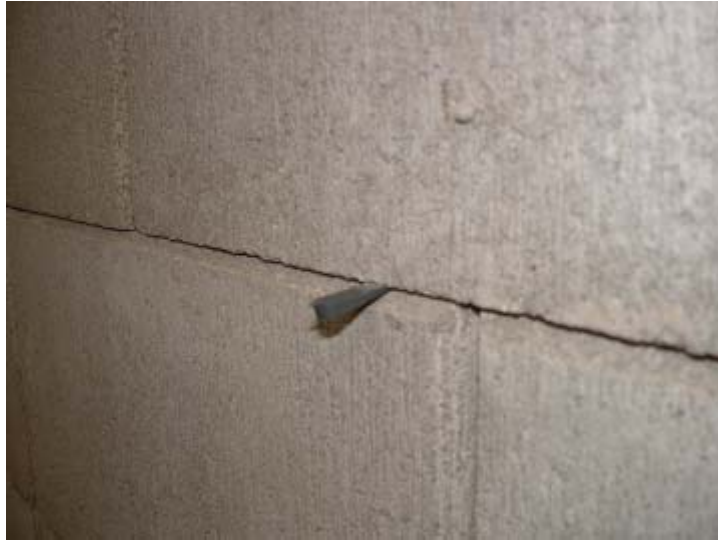
Figure 4-3 Plastic shims positioned at joints

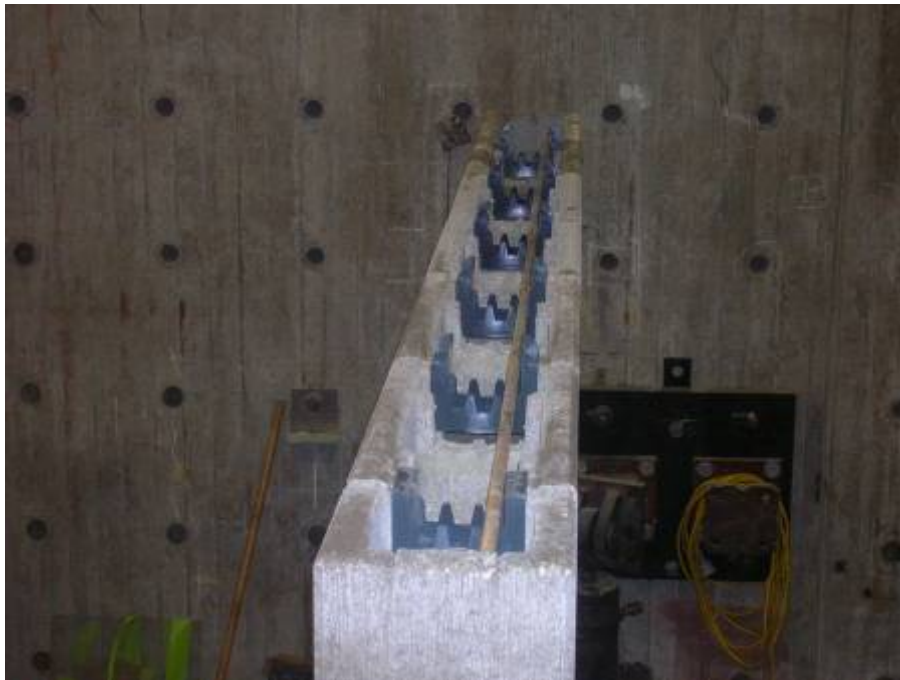
Figure 4-4 Reinforcement alignment using Form Bridge

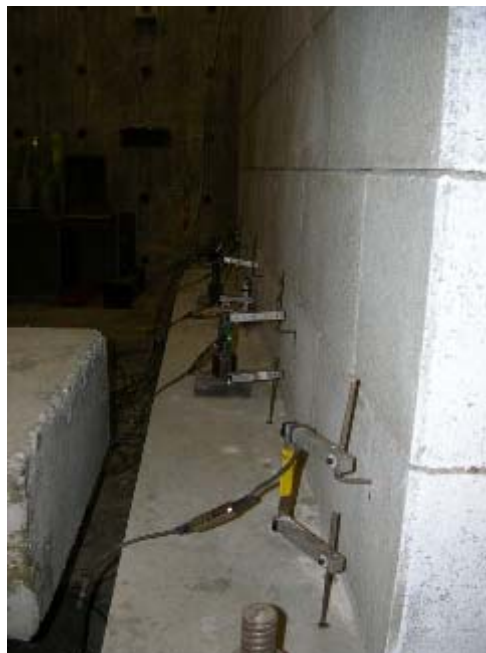
Figure 5-3 Instrumentation used to measure uplift at the base of the wall

The walls were instrumented with multiple devices to measure overall force vs. displacement response, as well as relative deformations associated with sliding and uplift of the wall. The instrumentation used in the testing is indicated in Figure 5-2 and 5-3.

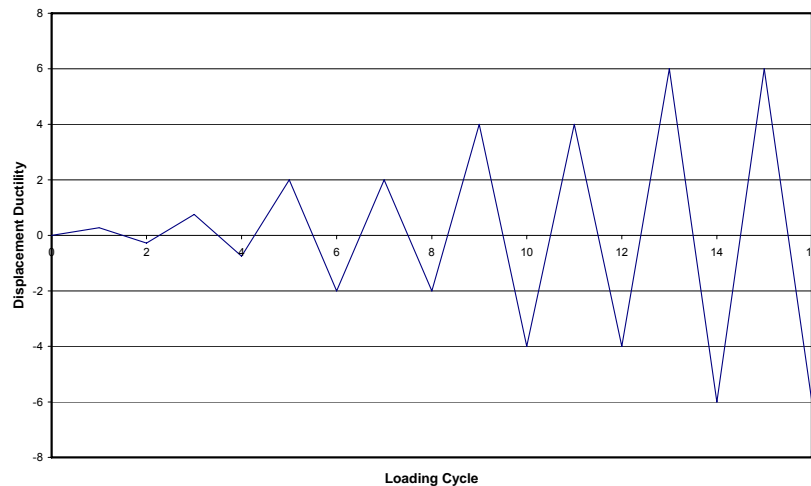
Figure 6-2 Planned loading cycle

The loading cycle used for the tests is illustrated in Figure 6-1. This loading cycle was adapted from that presented by Park⁹ and consists of several stages.

1. The system was first taken to the serviceability level load in each of the push and pull directions.

2. A load of $0.75F_n$ was applied in each direction. From this cycle an average displacement was extrapolated to find the ductility one displacements.
3. The structure was then taken through two full (\pm) cycles to ductility 2, then two to ductility 4, proceeding to increase the displacement in increments of ductility 2 until failure occurred. Failure was defined as having occurred when the lateral force sustained by the structure falls below 80% of the peak value sustained by the structure or when rupture occurred.

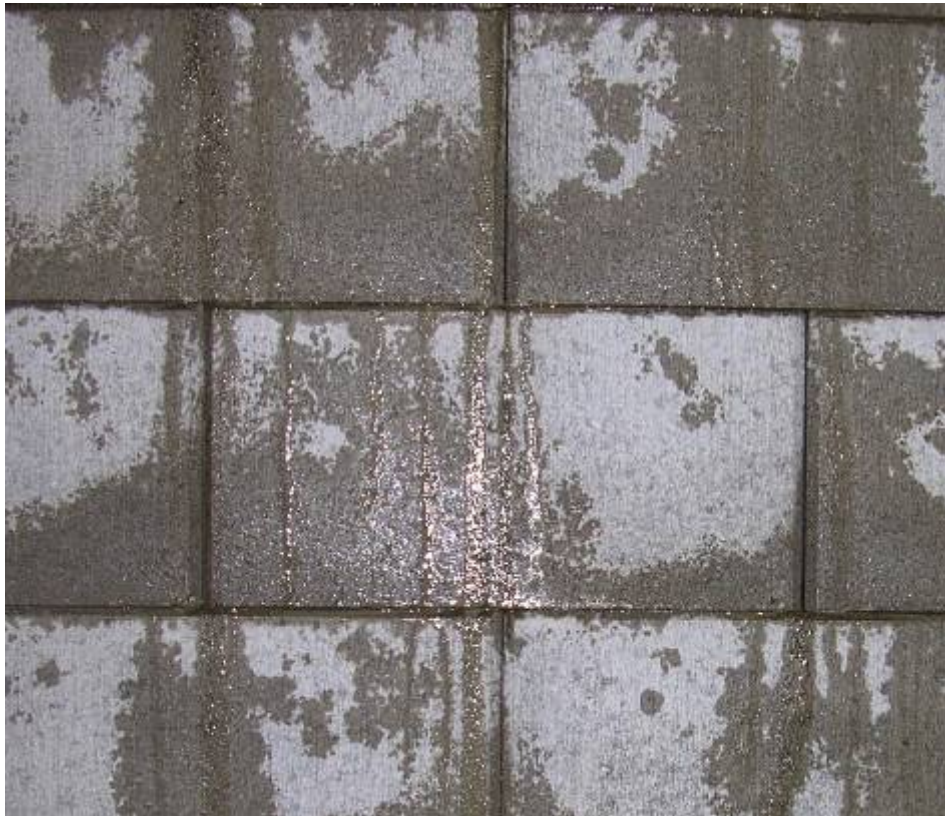
Figure 7-1 **Openings in joints on wall before testing**

A preliminary investigation of the wall revealed that numerous joints were open to a width of up to 3 mm (0.12 in.) as can be seen in Figure 7-1. Both wall faces appeared to be in a similar condition.

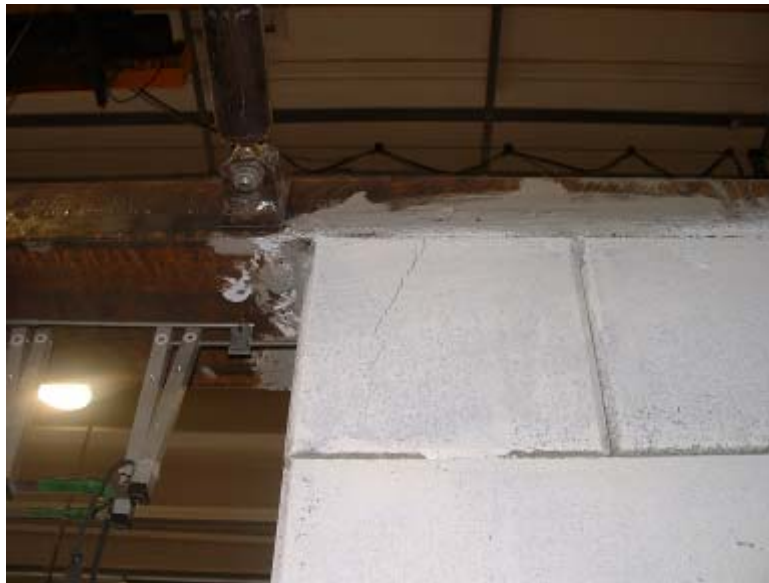
Figure 7-2 Crack at top corner on gauge end

A diagonal hairline crack had formed at the top corner of the wall on the gauge end which can be seen in Figure 7-2. A base crack had formed, less than 1 mm (0.039 in.) wide.

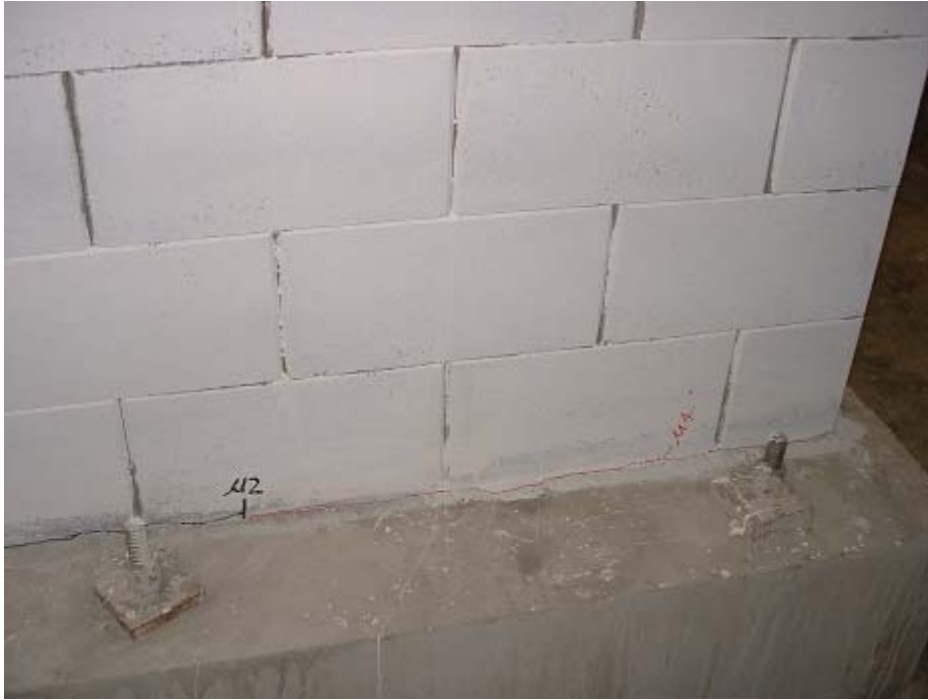
Figure 7-3 Base crack along total length of wall from both directions

The base crack now ran the full length of the wall in both directions, as shown in Figure 7-3.

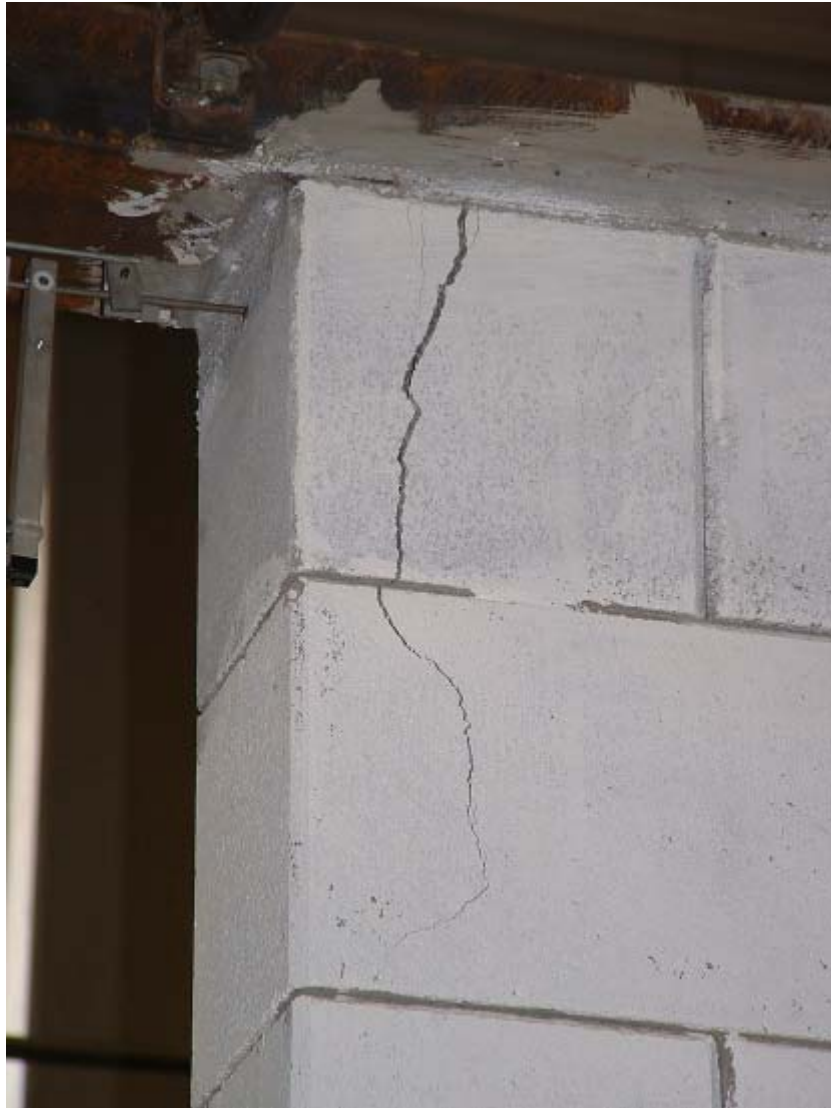
Figure 7-4 Crack at top corner now opened to 4 mm

The diagonal crack at the top corner of the wall had opened to approximately 4 mm (0.157 in.). This can be seen in Figure 7-4.

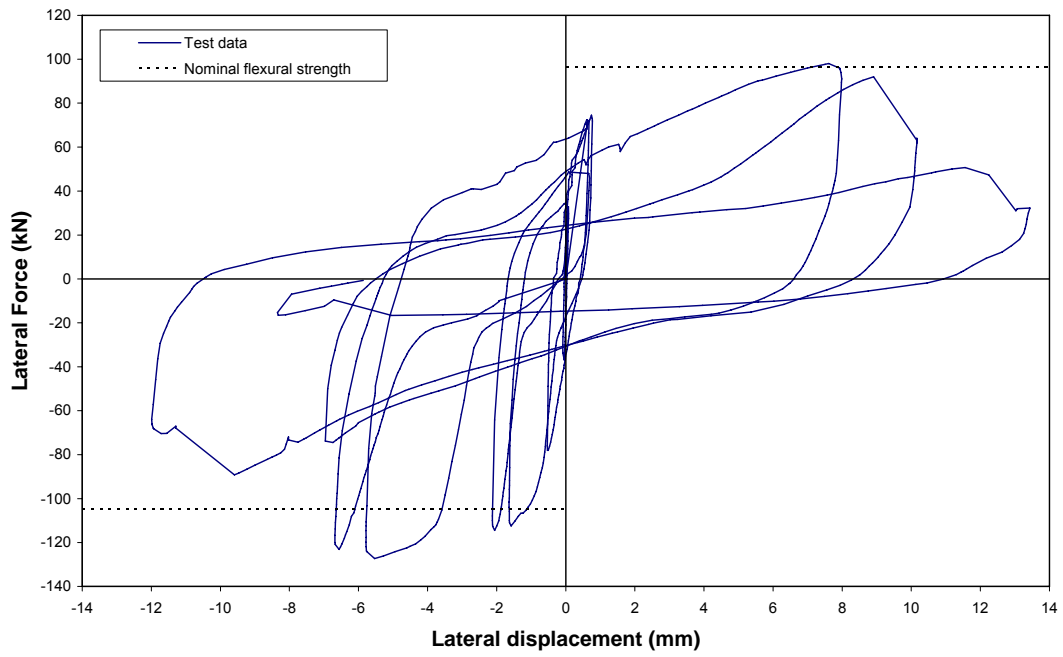
Figure 7-5 Displacement history of Commercial Wall 2 (metric)

Figure 7-6 shows the force-displacement history of Commercial Wall 2. Maximum strengths of 98 kN (22.03 kips) for the push direction (positive quadrant) and 127 kN (28.55 kips) in the pull direction (negative quadrant) were measured. This compares favourably with the calculated nominal flexural strengths.

In the push direction the wall survived a cycle to a ductility of $8.00/0.80 = 10.00$. In the pull direction the wall survived a cycle to a ductility of $-6.69/0.70 = 9.60$.

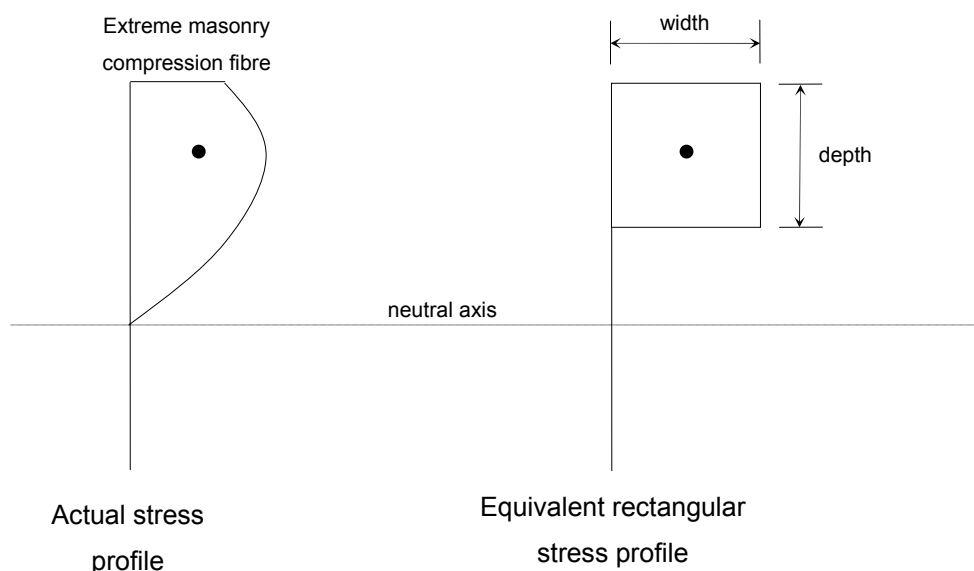
Equivalent masonry rectangular stress blocks:

Masonry design code	Equivalent rectangular stress block		Maximum useable strain at extreme masonry compression fibre
	Width	Depth	
NZS 4230:2004 ¹	$0.85 \times f'_m$	$0.85 \times c$	0.0030
MSJC ²	$0.80 \times f'_m$	$0.80 \times c$	0.0025
AS 3700:2001 ³	$0.85 \times 1.3 \times f'_m$ ⁵	$0.85 \times c$	0.0035
BS 5628-2:2005 ⁴	f_k/γ_{mm}	$1.0 \times c$	0.0035
